STAFF REPORT

To: Council
From: Adam Dedrick, Director of Recreation & Parks
Approved by: Warren MacLeod, Chief Administrative Officer
Date: December 10, 2025
Subject: Jordan River Trail Bridge Visual Inspection Report

RE: *Jordan River Trail Bridge – Visual Inspection Memo*

Report No: 254216.00

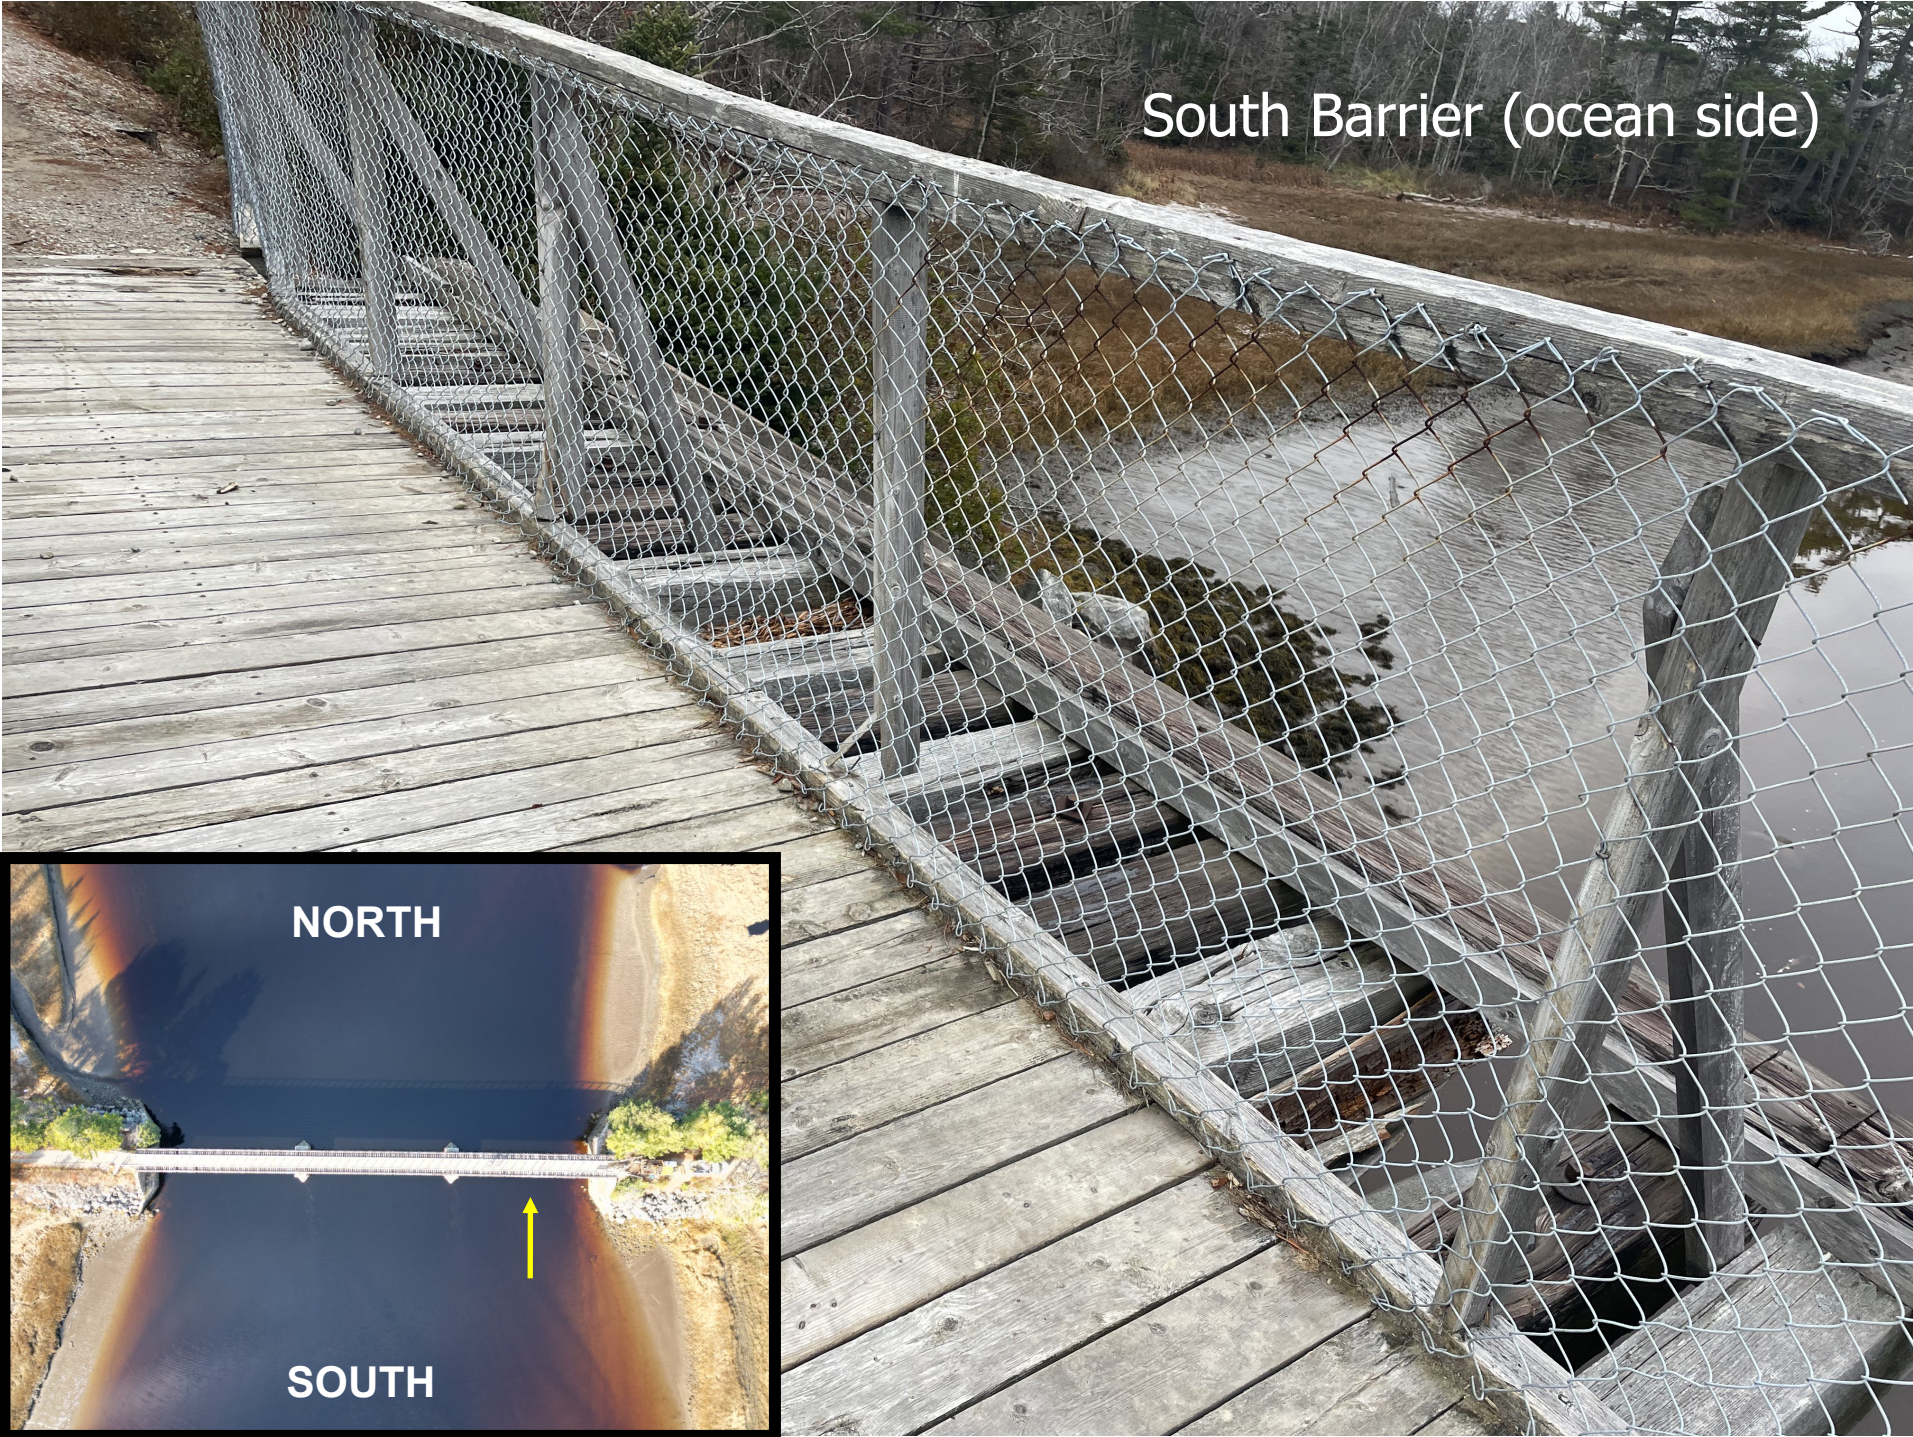
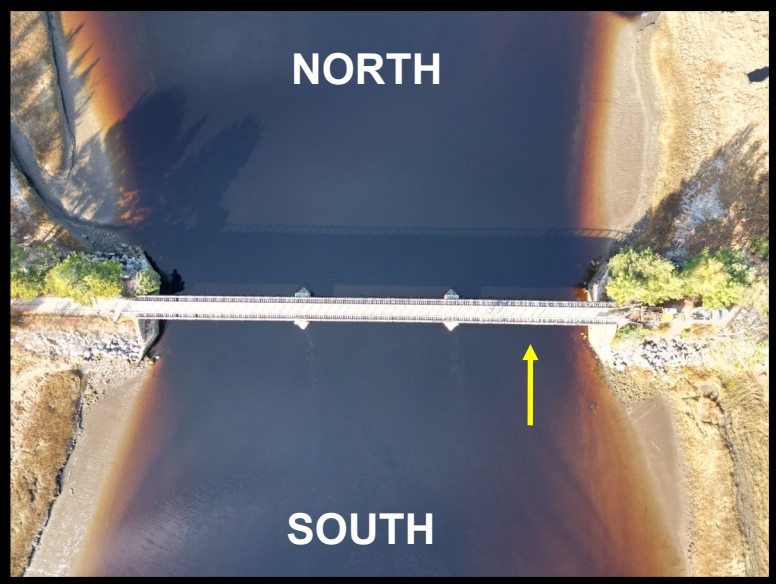
South Barrier (ocean side)

As a result of these deficiencies, the barrier system is unstable. There are multiple locations on the south side where the barrier can be easily displaced by hand, indicating that a weakened section will not be able to withstand impact from an off-highway vehicle. While the north side exhibits similar deterioration, it remains comparatively more stable than the south side. It is recommended that the south side barrier is replaced or rehabilitated before the bridge is replaced. Alternatively, as mentioned above, the bridge could be closed to off-highway vehicles.

Based on the results of the visual inspection and the safety of users being priority, the Jordan River Trail Bridge has been closed to off highway vehicles and it is recommended for this closure to remain. When asked, CBCL advised that the bridge should be closed to OHVs immediately. Boulders have been installed at each end of the bridge as barriers and repairs to the south barrier are being arranged.

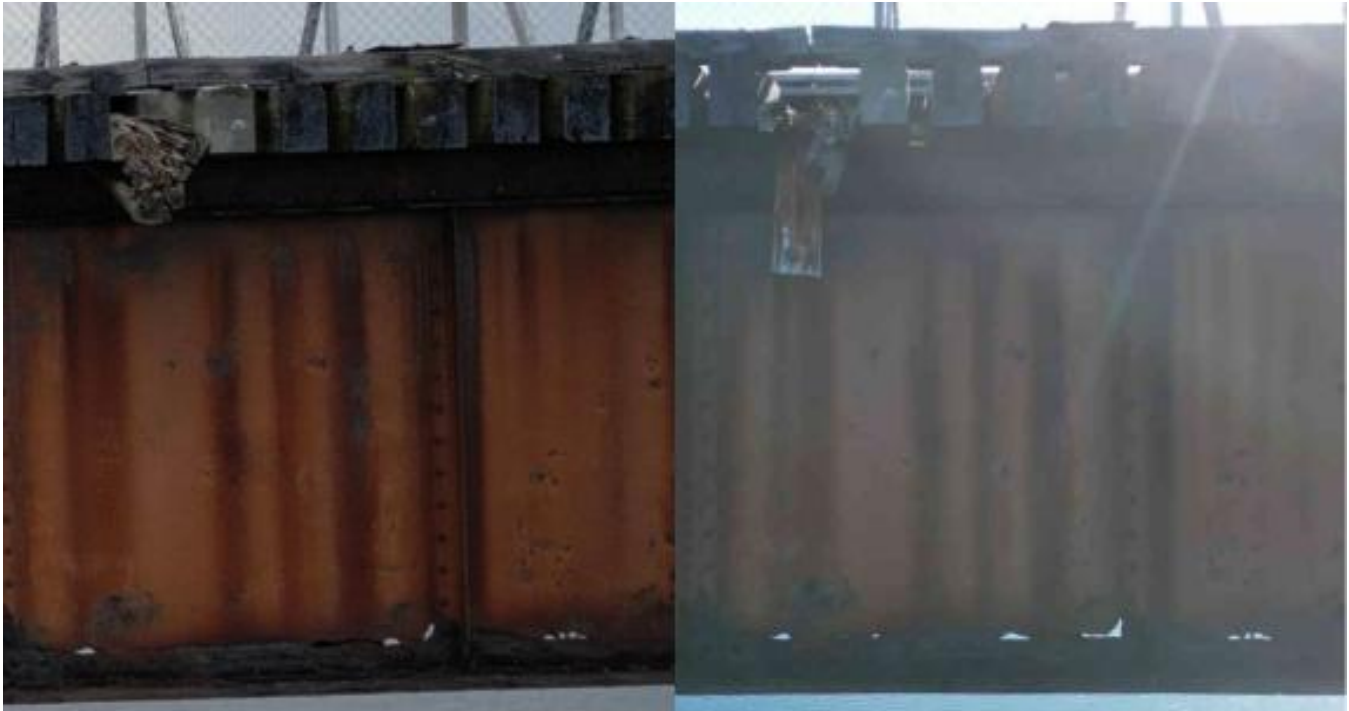
Figure 3 - North girder, Span 2 (viewed from west to east), showing condition comparison between 2023 (left) and 2025 (right). Increase in existing section loss and new areas of section loss forming.

The steel superstructure remains the most significant concern for the overall structural integrity of the bridge. Deterioration has continued since the previous inspection, with section loss in the webs becoming more pronounced. Several new minor areas of section loss have developed, and previously identified areas have slightly increased in severity. From the previous assessment, the steel superstructure had enough capacity to continue under its current service conditions. CBCL still believes this to be true even with the slightly worsened defects.

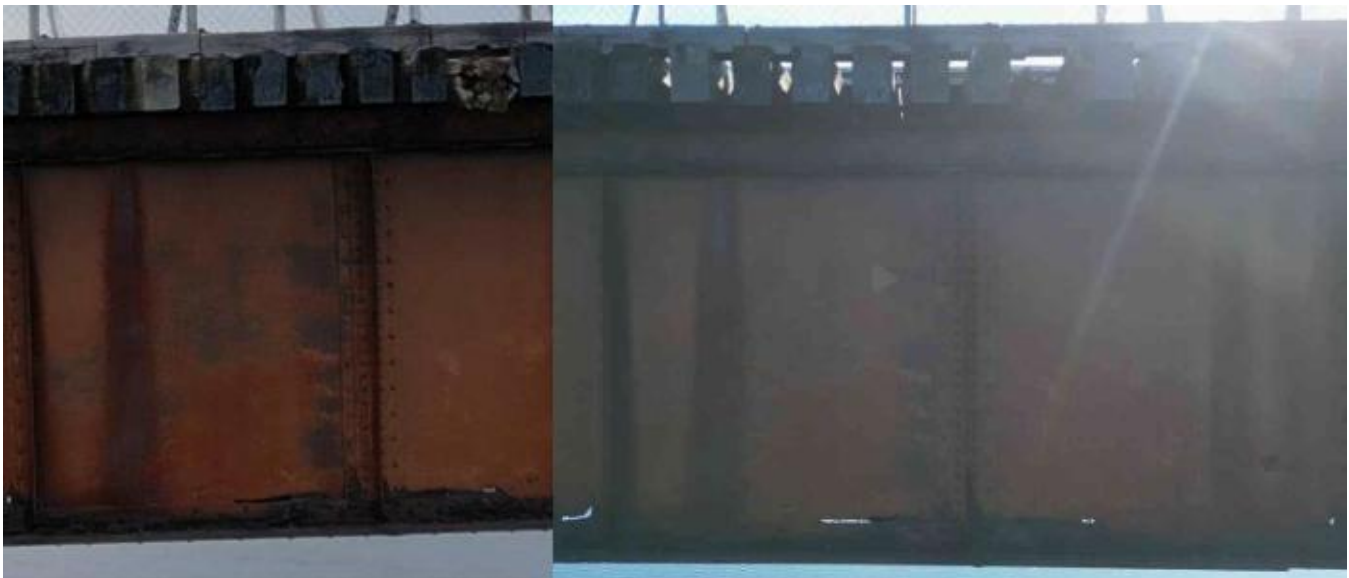
Figure 4 - North girder, Span 3 (viewed from west to east), showing condition comparison between 2023 (left) and 2025 (right). Similar conditions.

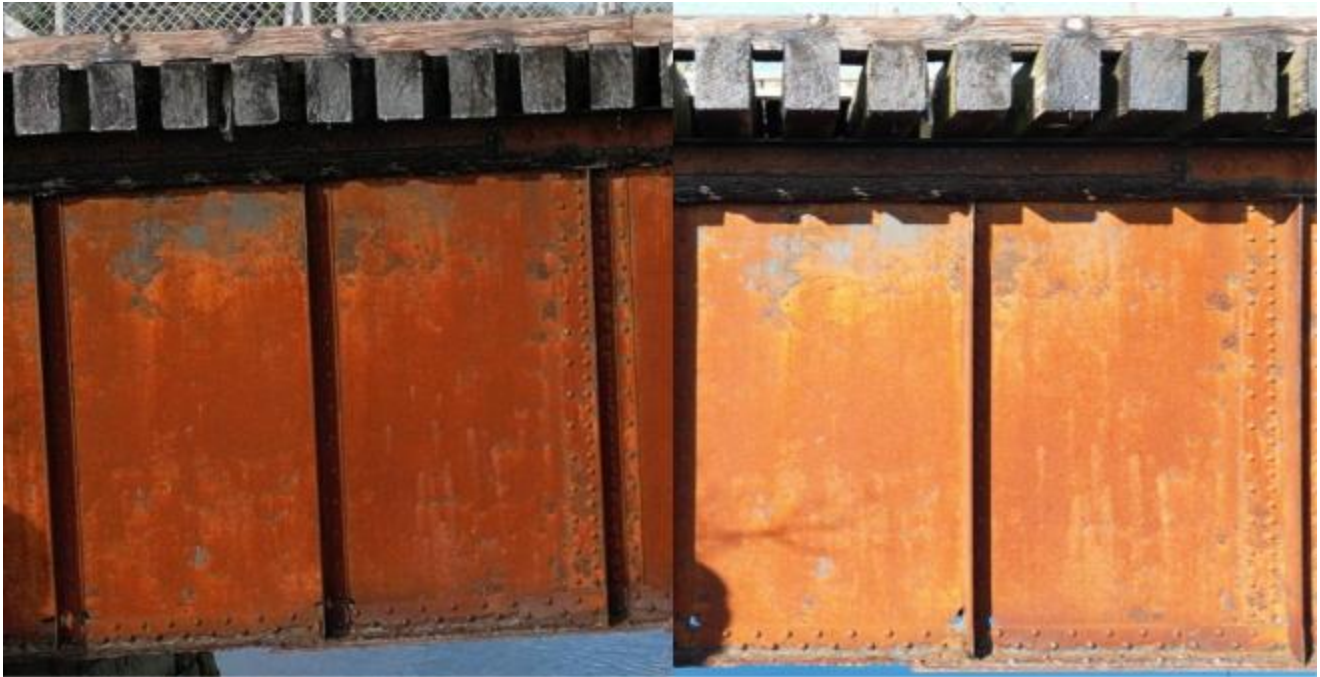
Figure 5 - South girder, Span 1 (viewed from west to east), showing condition comparison between 2023 (left) and 2025 (right). New section loss forming on the web and stiffener.

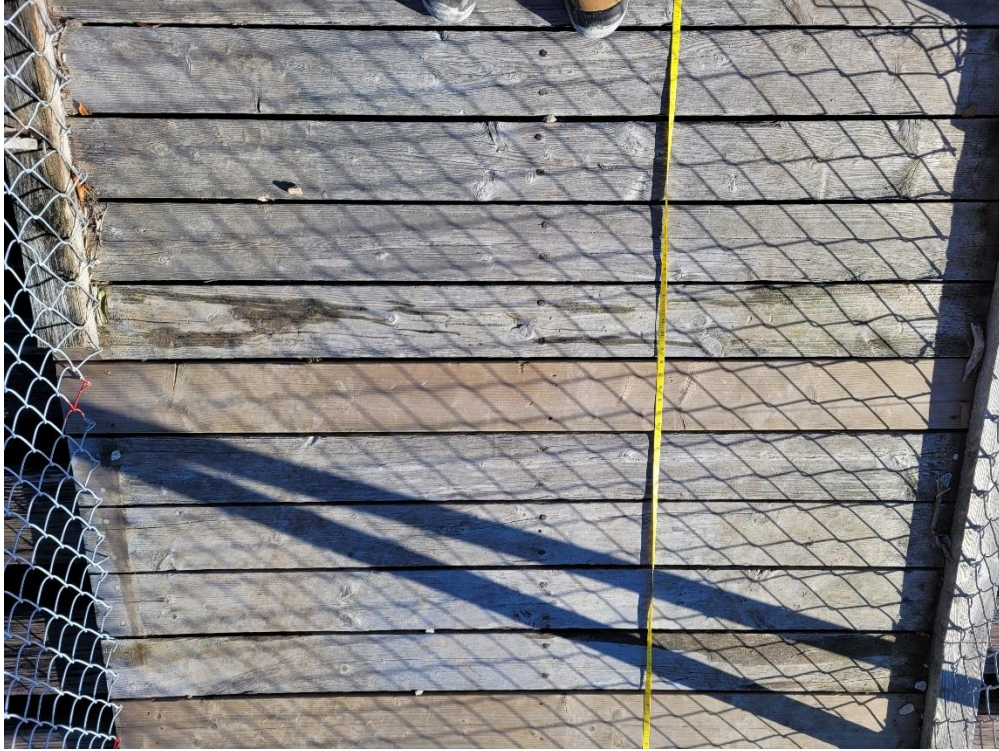
The timber deck planks run transversely across the bridge and are supported by three longitudinal stringers, which connect into the timber ties. The deck planks were visually assessed and sounded using a hammer to evaluate their condition. A significant number of planks appear to have been recently replaced and are generally in good condition. However, several of the older planks that have not been replaced exhibit signs of deterioration (See Photo 3, Appendix A). Observed deficiencies include areas of rot present throughout several of the original wooden deck planks. In addition, minor checks and splits were noted across these older planks as well.

Overall, the deck is in good condition and remains functional for its intended use.

Photo 3: Typical view of timber deck planks, with several boards replaced.

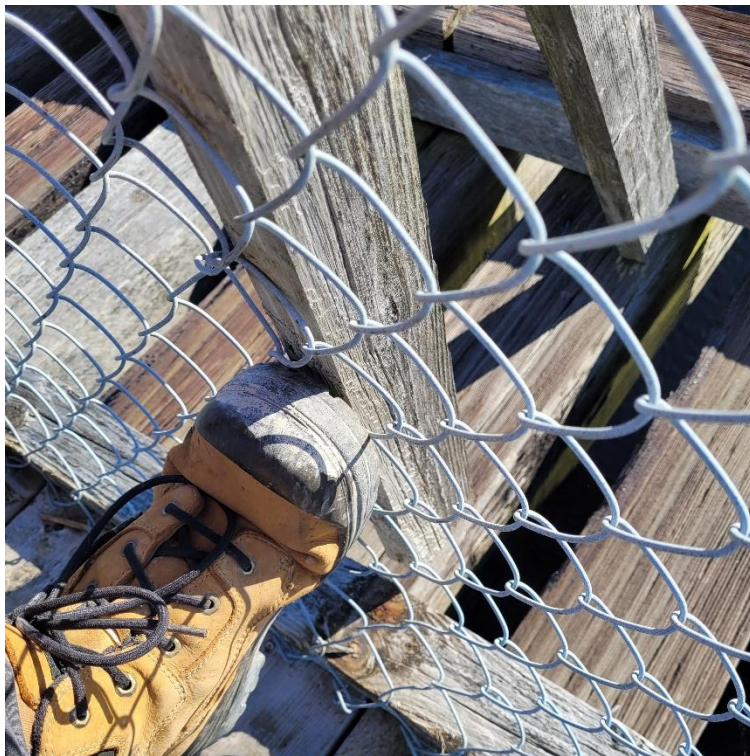
The timber barrier system consists of timber posts, double timber top railings, a bottom frame, timber struts connected to the supporting ties, and a chain-link mesh. Multiple posts exhibit signs of impact damage (See Photo 8 and Photo 9, Appendix A), resulting in dislodged connections or complete post failure (See Photo 7, Appendix A). Barrier components show widespread checking and splitting, in some cases, completely through the members (See photo 10, Appendix A). On the south barrier, large portions of the double top railing and sections of the bottom frame are missing. Numerous connections have failed as nails have been dislodged, or the members have experienced section loss. Rot is present throughout the barrier system, contributing significantly to its instability.

Photo 4: Typical view of a barrier post completely disconnected, south barrier.

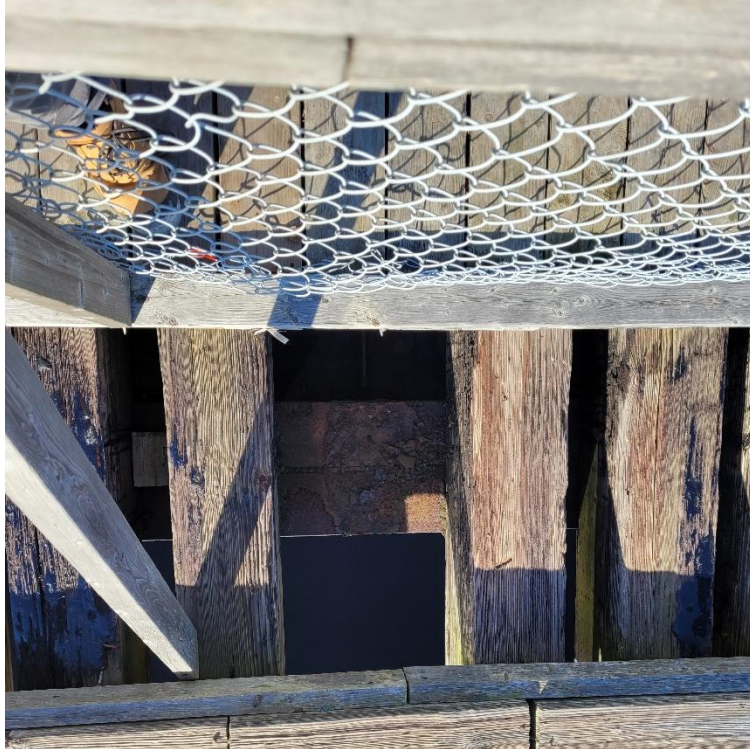
Like the deck planks, the timber ties run transversely across the bridge and are supported by two longitudinal steel girders. The ties were assessed visually, and some were accessed to hammer sound. The ties are aging and exhibit significant deterioration, including extensive checking and splitting, as well as rot in the sounded members. A total of 14 ties have experienced severe section loss (see Photo 5 and Photo 6, Appendix A).

Overall, the ties are in poor condition. While there some members that appear to be in acceptable condition, there are multiple members with severe defects. Without being able to access all the ties, we cannot ensure that the ties that look to be in good condition are structurally sound and have

Photo 5: Typical view of a missing timber tie, south side.

capacity to handle loading from off-highway vehicles. CBCL recommends either replacing the timber ties or limiting access for off-highway vehicles.

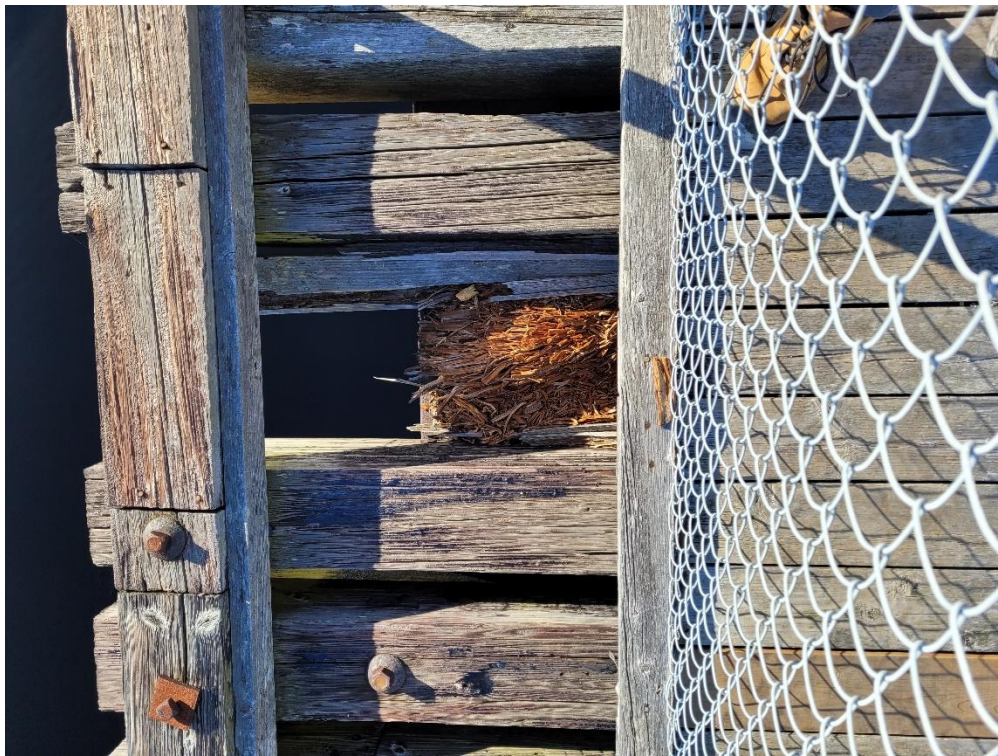
Photo 6: Typical view of a deteriorated timber tie, south side.

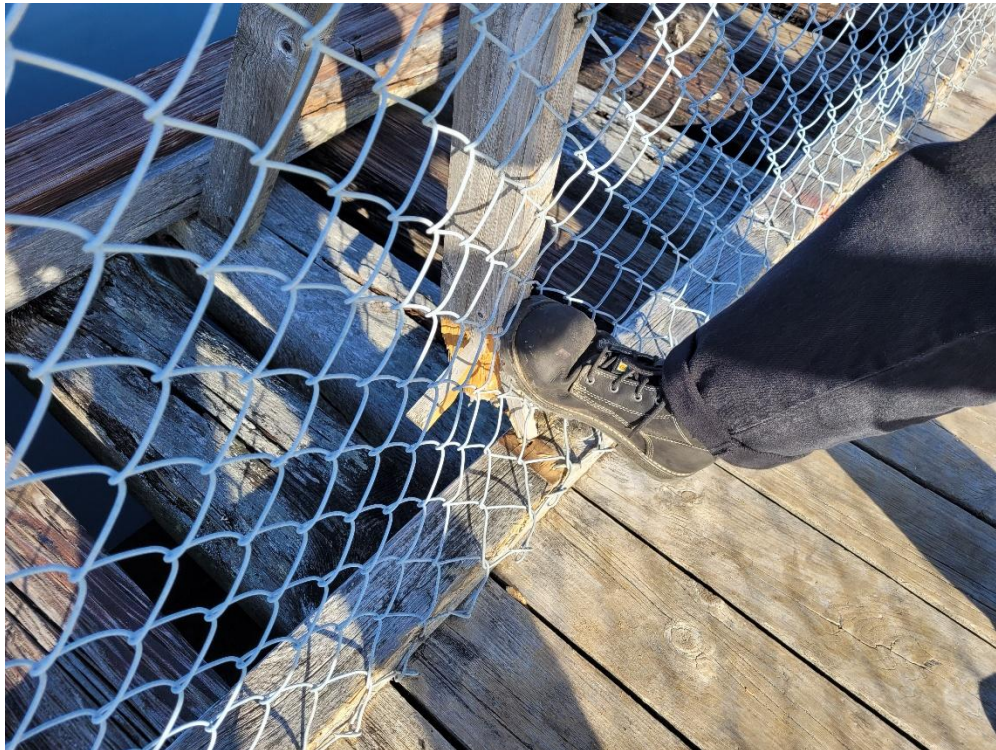
Photo 7: Typical view of a barrier post completely disconnected, north barrier.

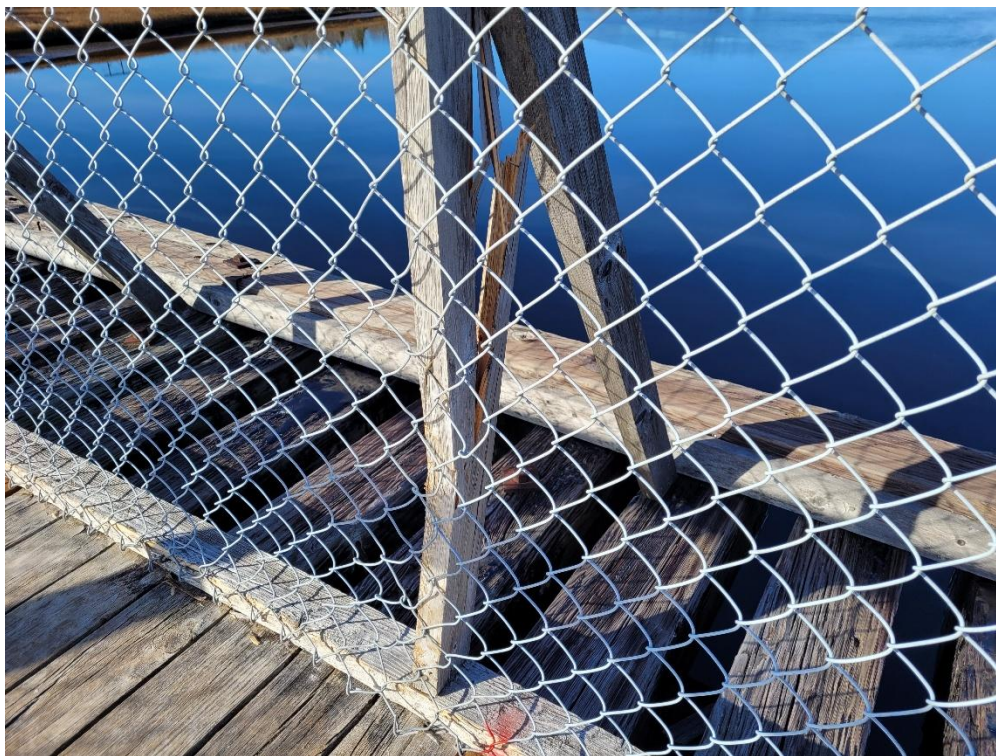
Photo 8: Typical view of barrier impact damage, north barrier.

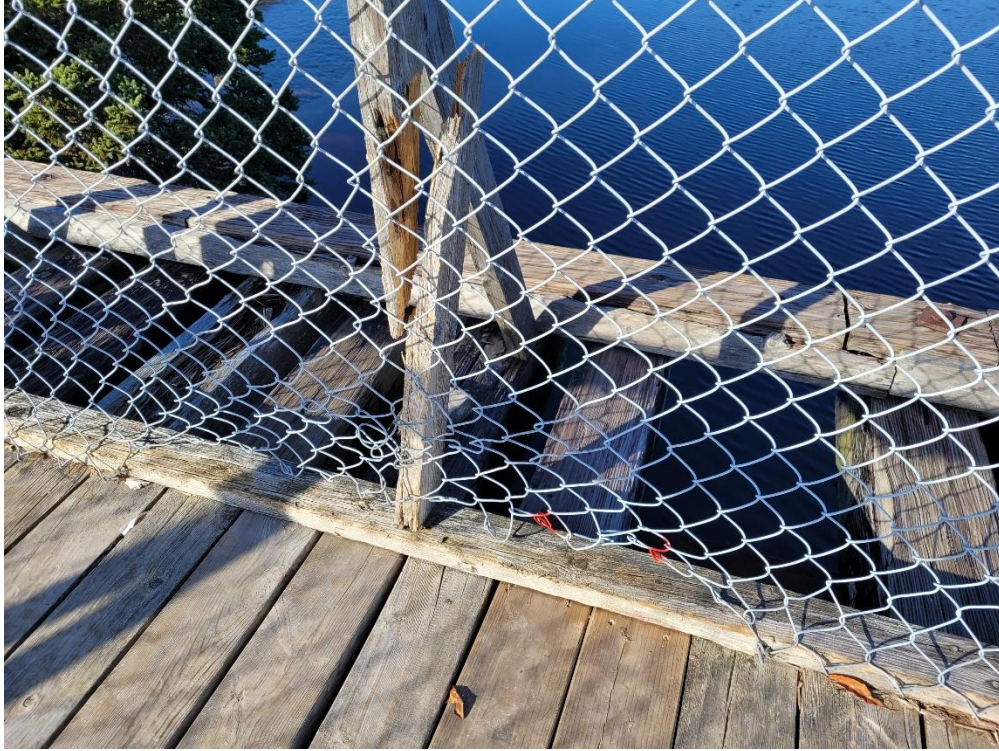
Photo 9: Barrier impact damage resulting in a damaged post, north barrier.

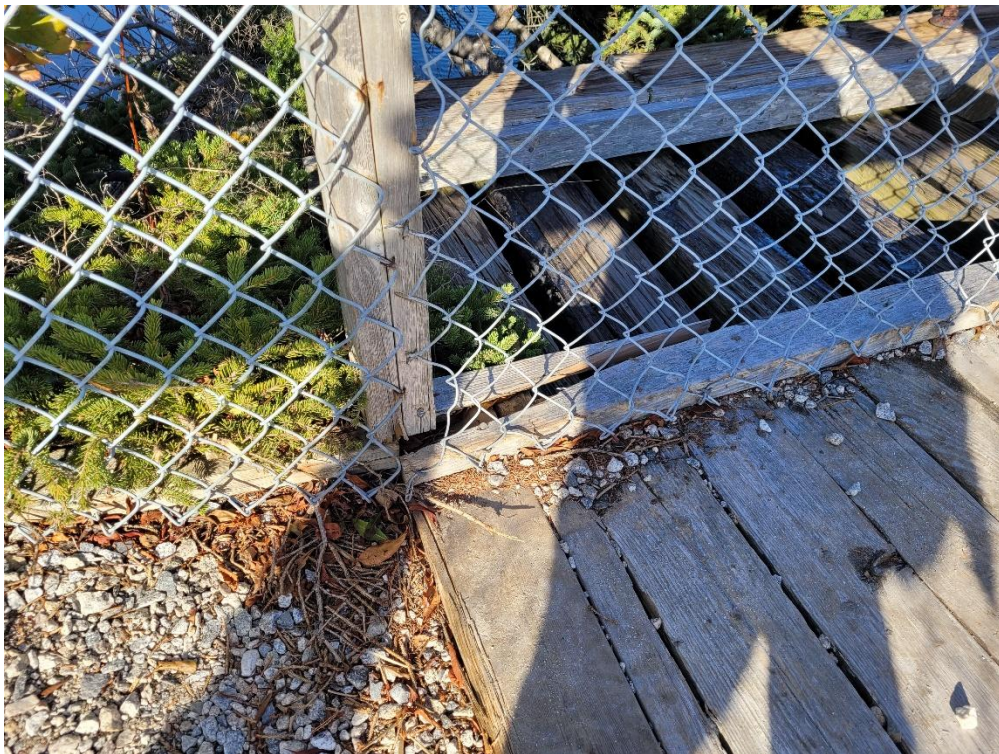
Photo 10: Typical connection damage with splits and checks throughout the timber.

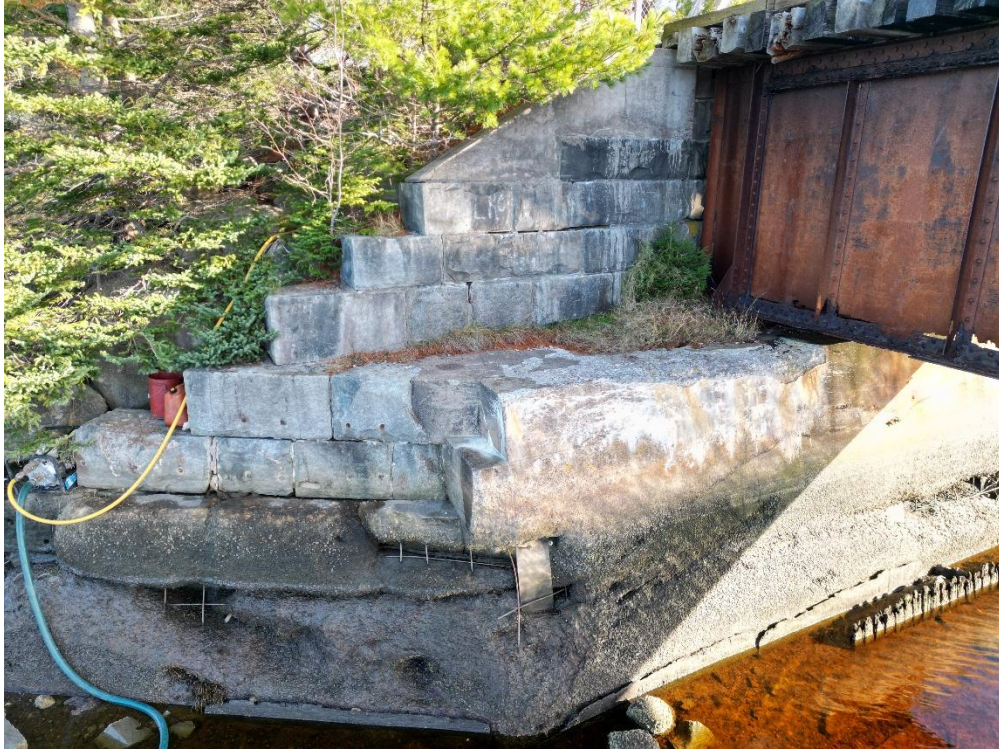
Photo 11: Cast-in-place concrete atop masonry stones at the east abutment near the girders.

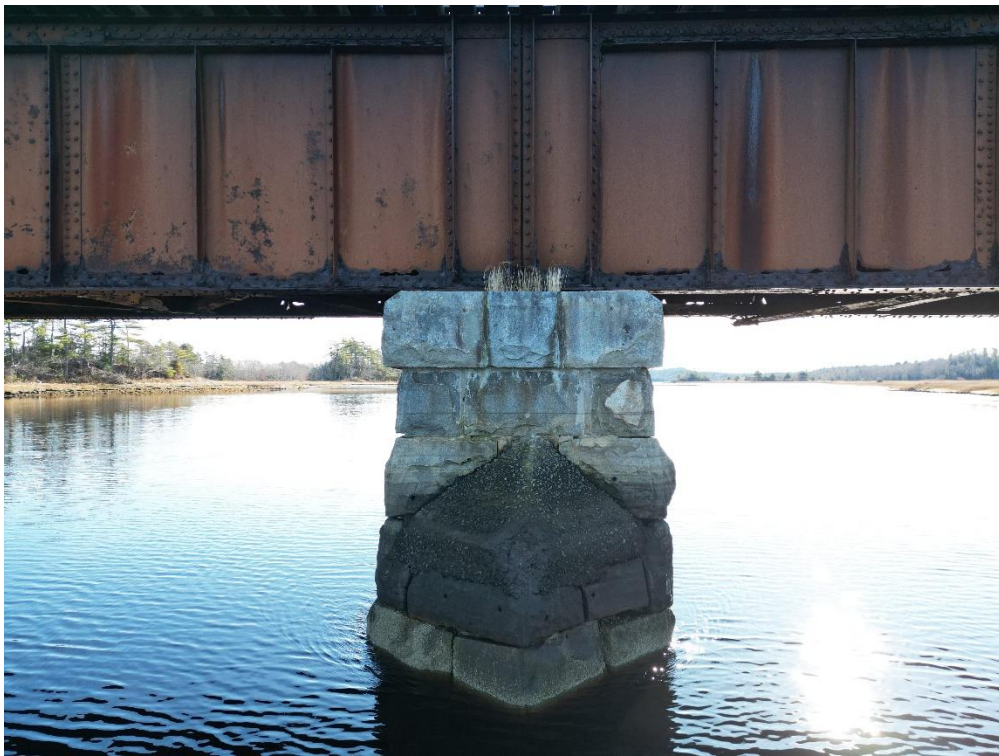
Observed deficiencies include extensive loss of mortar joints throughout the abutments and piers. Severe erosion of the concrete jacket on the east abutment's bottom row has exposed reinforcement and filler material (See Photo 17, Appendix A). Similarly, the north noses of the piers show significant erosion, exposing the aggregate (See photo 12, Appendix A). Some masonry blocks at the northwest and southwest corners of the west abutment, as well as the south faces of the piers are slightly dislodged (See Photos 13-15, Appendix A), but do not seem to have shifted position significantly compared to the previous inspection.

Photo 12: Typical erosion and scaling on pier nose.

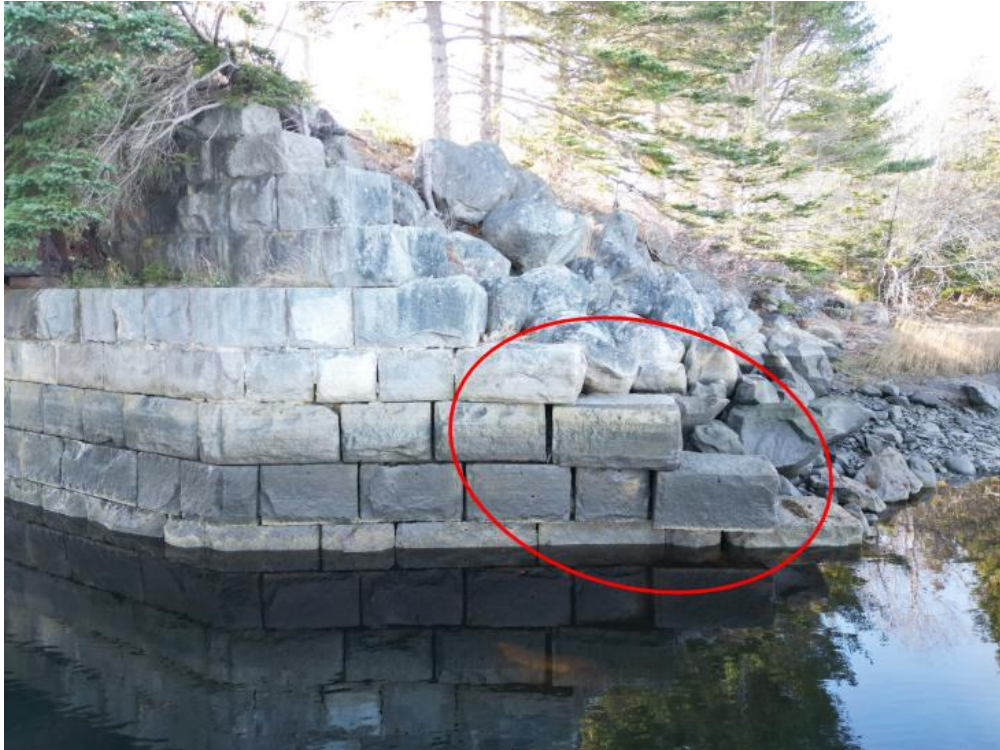
Photo 13: Dislodged masonry stones at the northwest abutment.

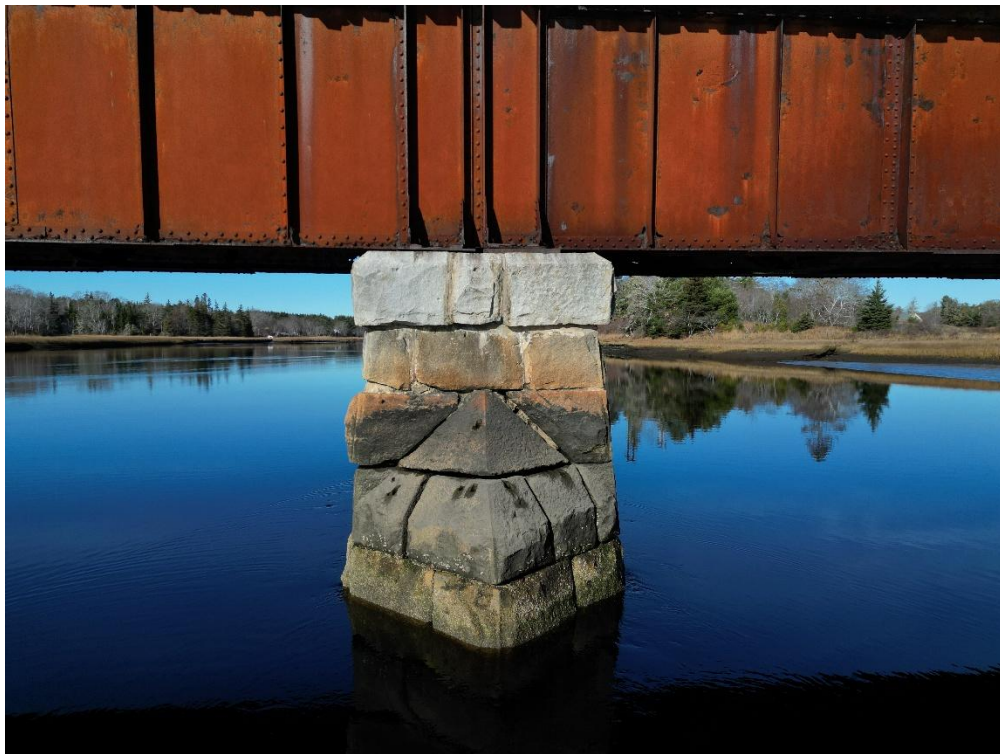
Photo 14: Slightly dislodged masonry stones on the south face of the piers.

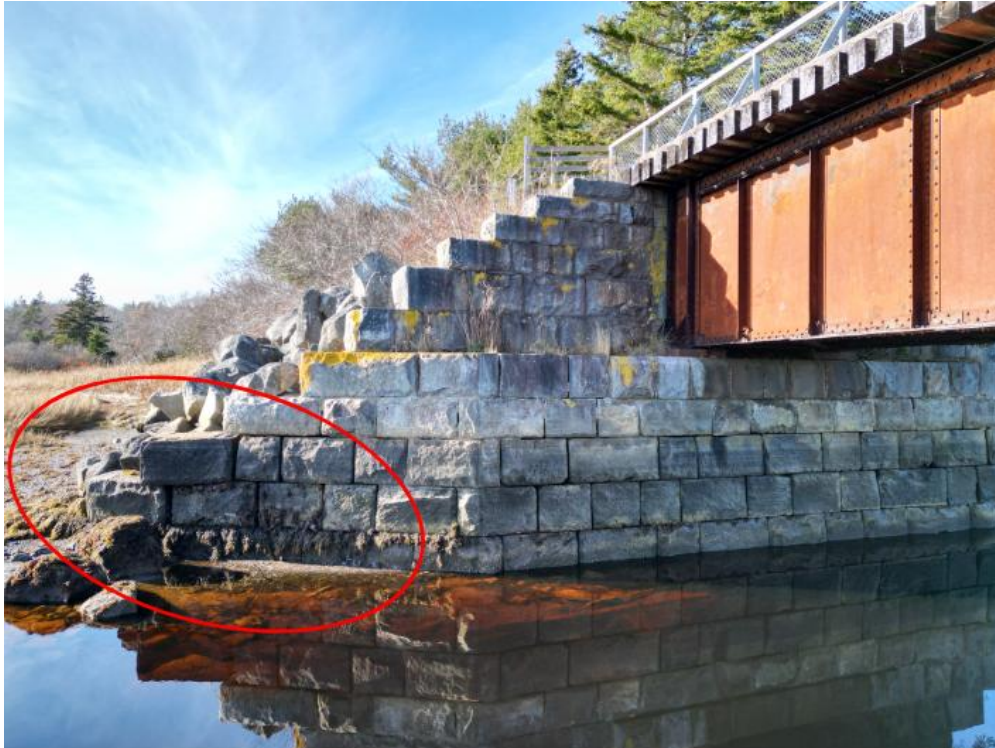
Photo 15: Dislodged masonry stones at the southwest abutment.

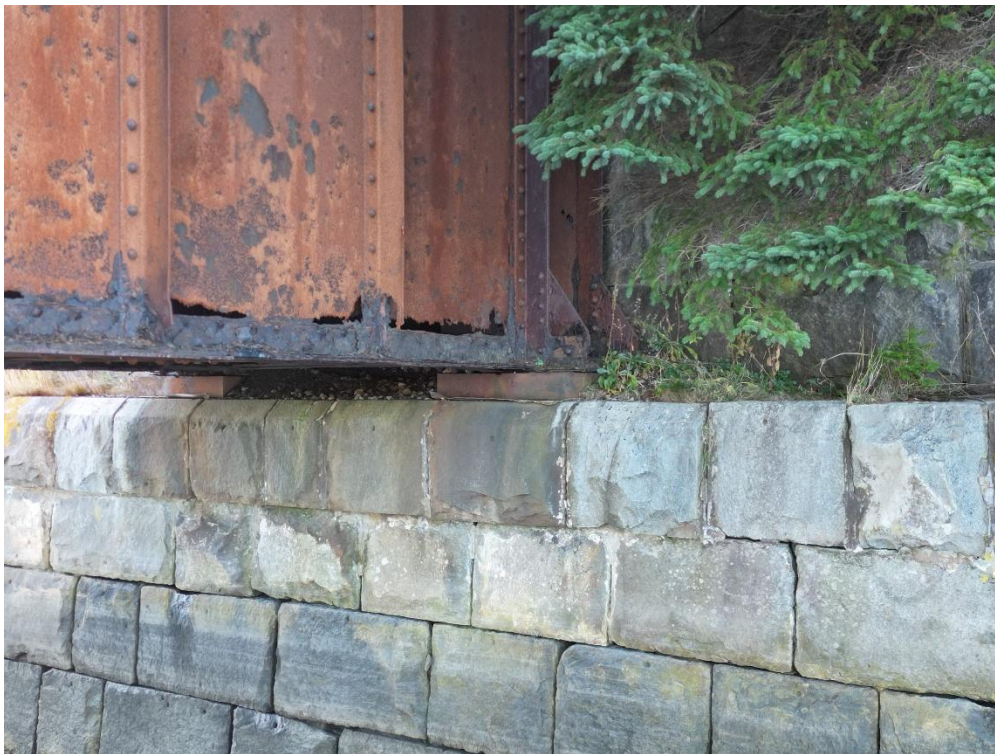
Photo 16: Typical view of superstructure bearings at the west abutment.

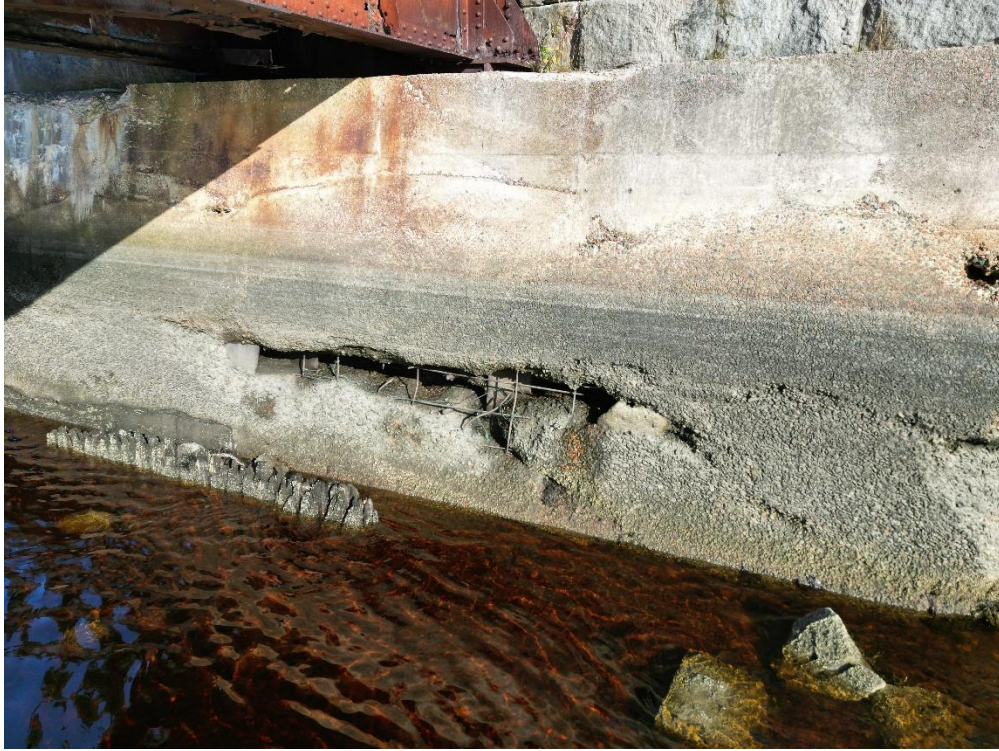
The observed deficiencies within the abutments and piers are primarily durability-related and do not currently pose a significant risk to the structural integrity of the bridge. These issues would normally warrant monitoring and eventual repair to prevent further deterioration, but they are not expected to compromise the load-carrying capacity of the bridge within the next one to two years under its current service conditions.

Photo 17: Severely eroded concrete jacket at the east abutment, with exposed reinforcement and other filler material (1).

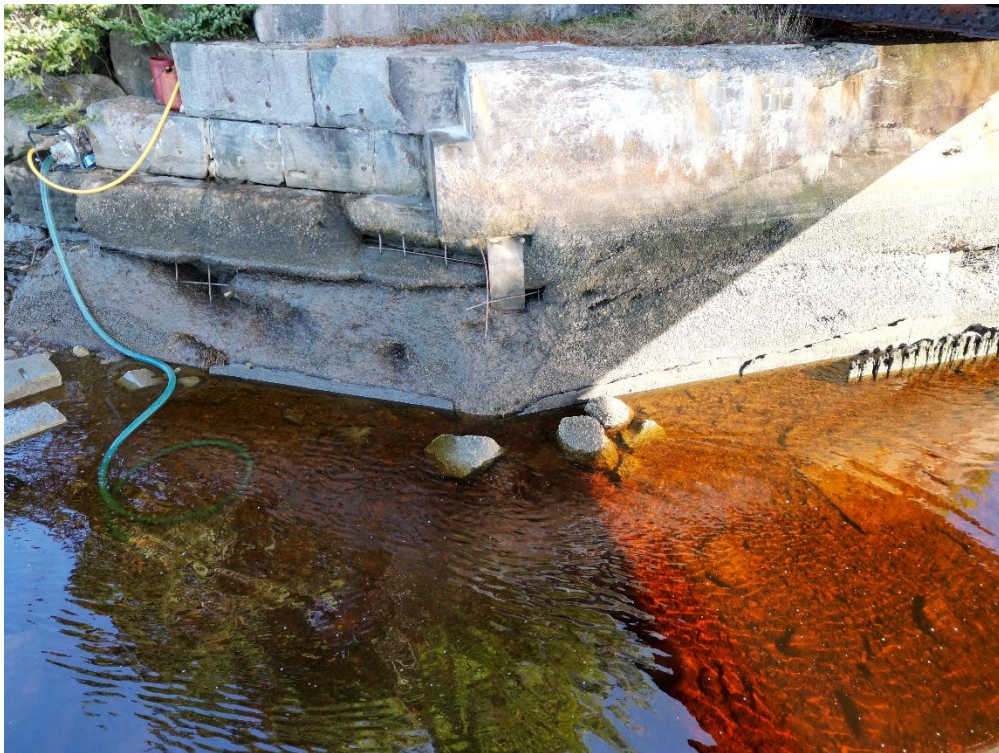
Photo 18: Severely eroded concrete jacket at the east abutment, with exposed reinforcement and other filler material (2).

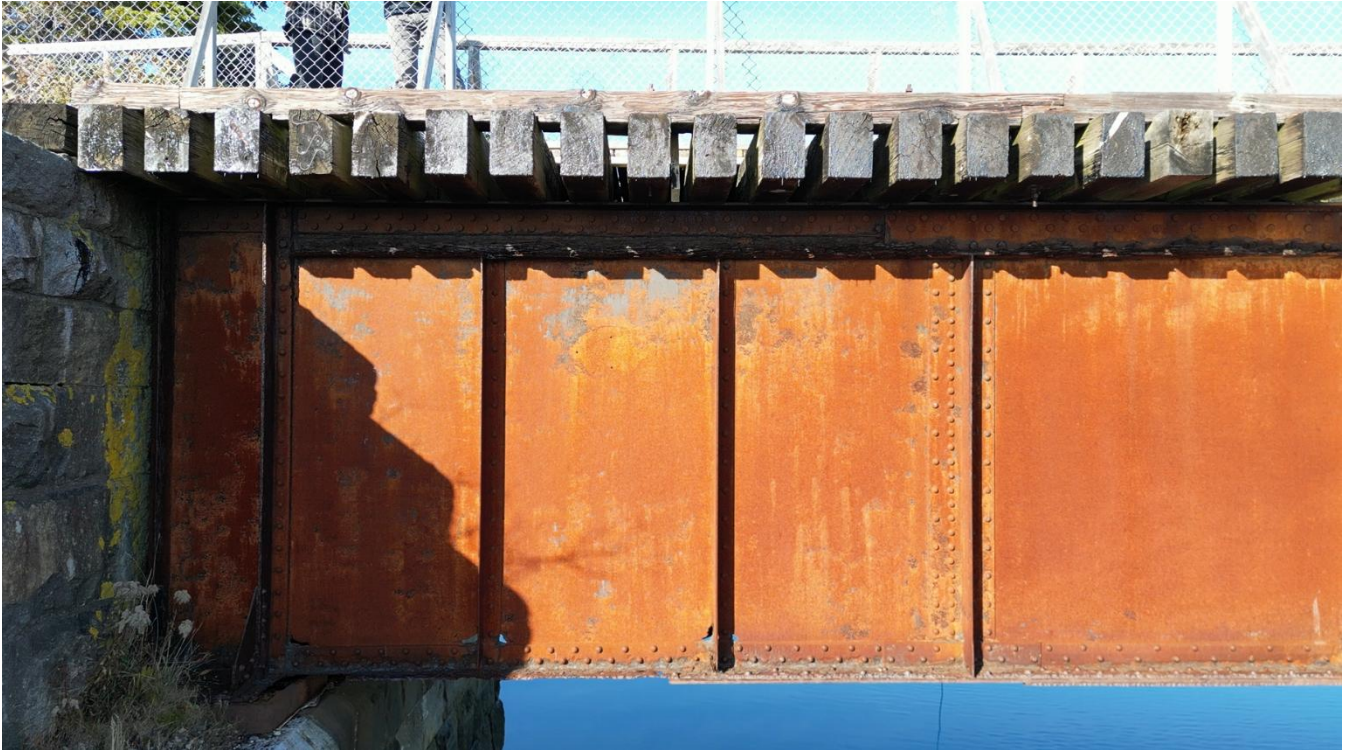
The upper portions of the girders have light to moderate corrosion with no apparent section loss in these areas. In contrast, the bottom portions of the girders exhibit severe corrosion, resulting in significant section loss. This deterioration extends to the webs, bottom flanges, and stiffeners. Most of the section loss has occurred on the webs. See **Figure 3**, **Figure 4**, and **Figure 5** below for a comparison between the 2023 and 2025 inspections.

Photo 19: Severe corrosion on the south girder near the west abutment, resulting in section loss.

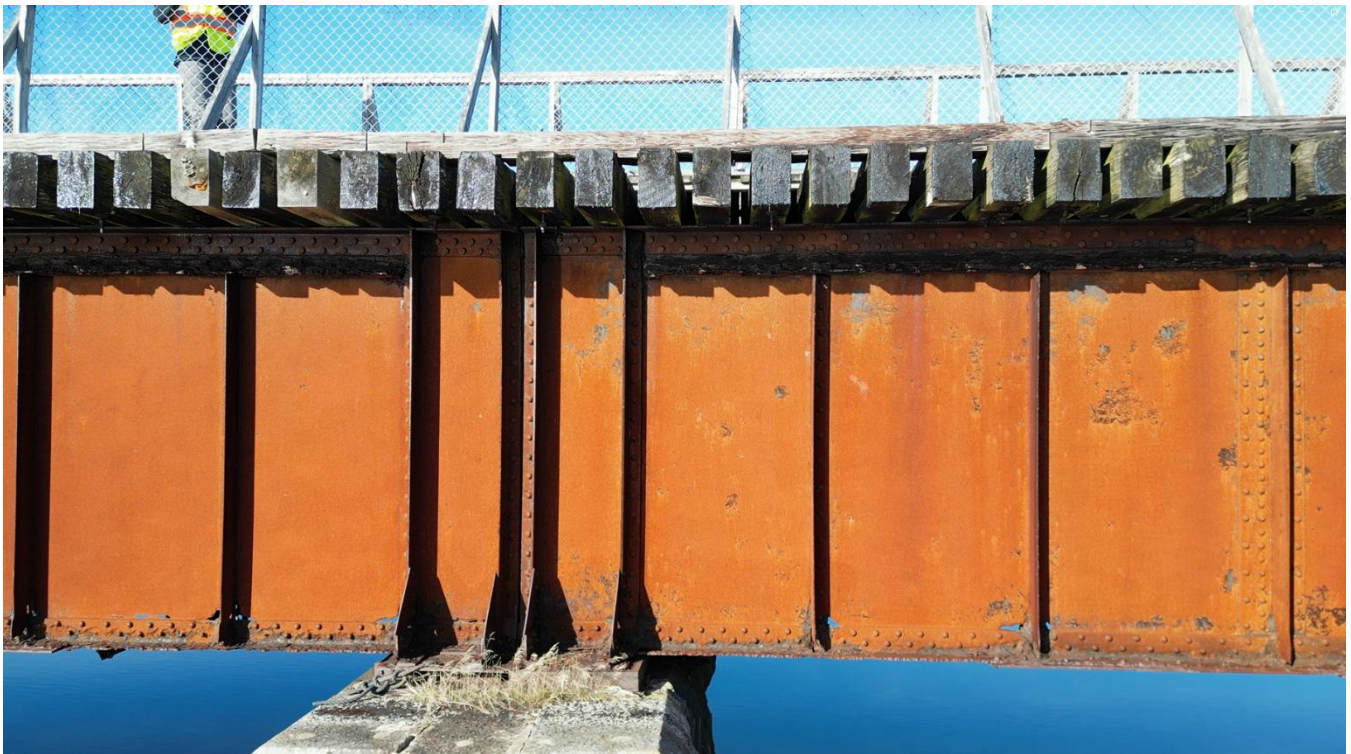
Photo 20: Severe corrosion on the south girder near the west pier, resulting in section loss.

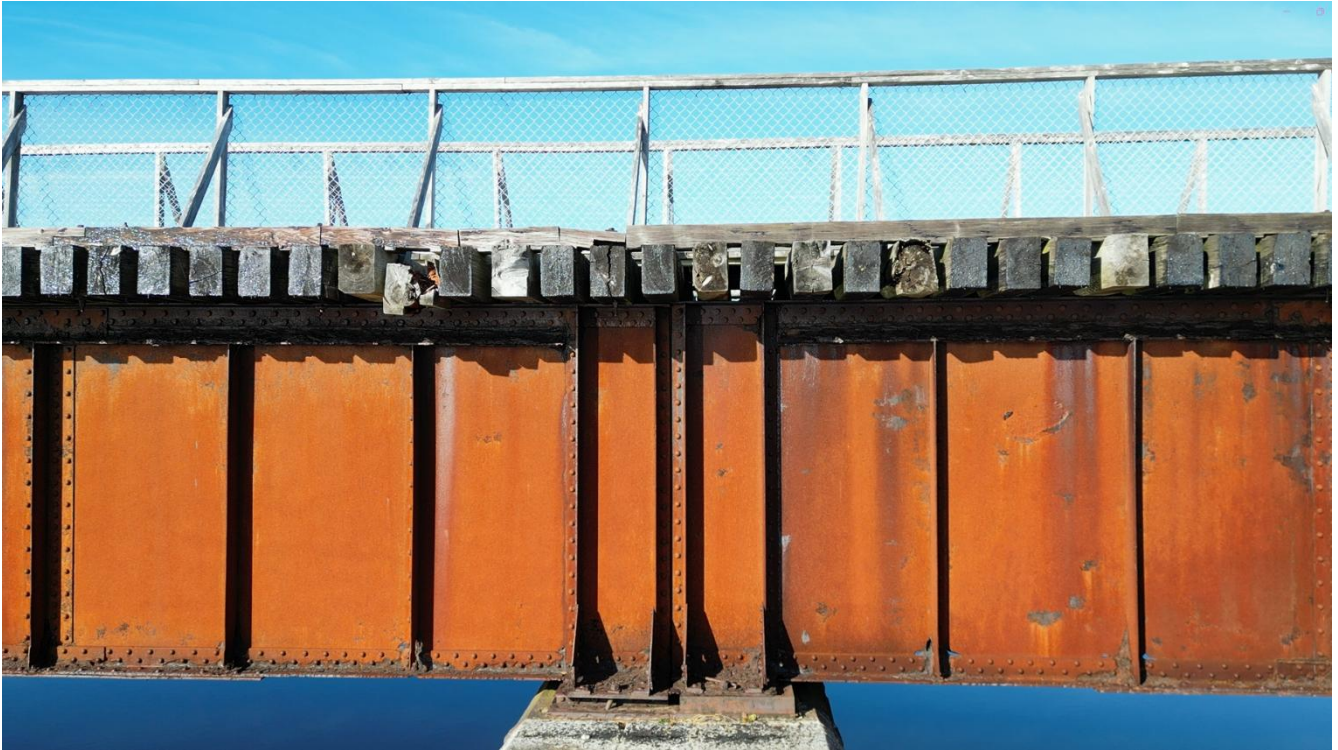
Photo 21: Severe corrosion on the south girder near the east abutment, resulting in section loss.
