STAFF REPORT

To: Council
From: Adam Dedrick, Director of Recreation & Parks
Approved by: Warren MacLeod, Chief Administrative Officer
Date: December 10, 2025
Subject: Jordan River Trail Bridge Visual Inspection Report

RE: *Jordan River Trail Bridge – Visual Inspection Memo*

Report No: 254216.00

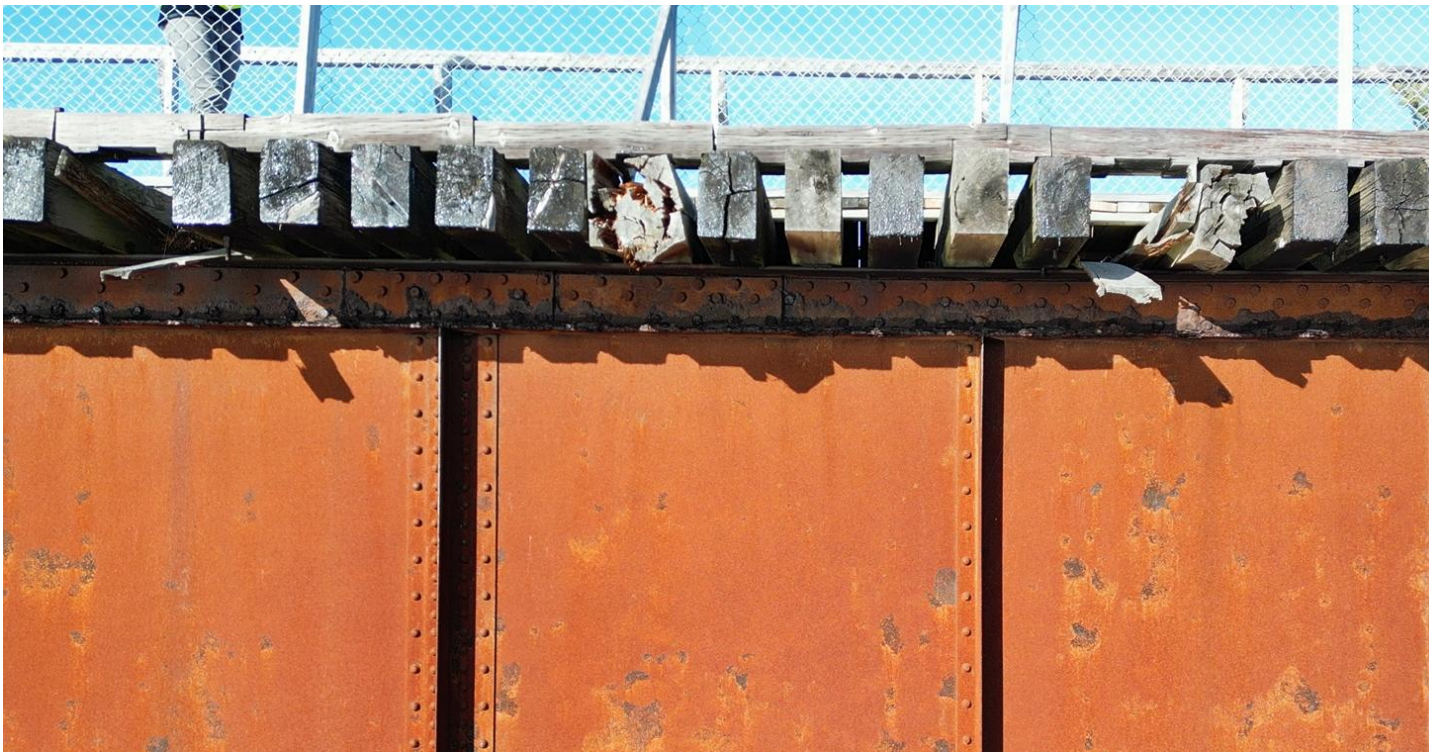
Photo 22: View showing a missing tie, a deteriorated tie, and a severely damaged tie, south side.

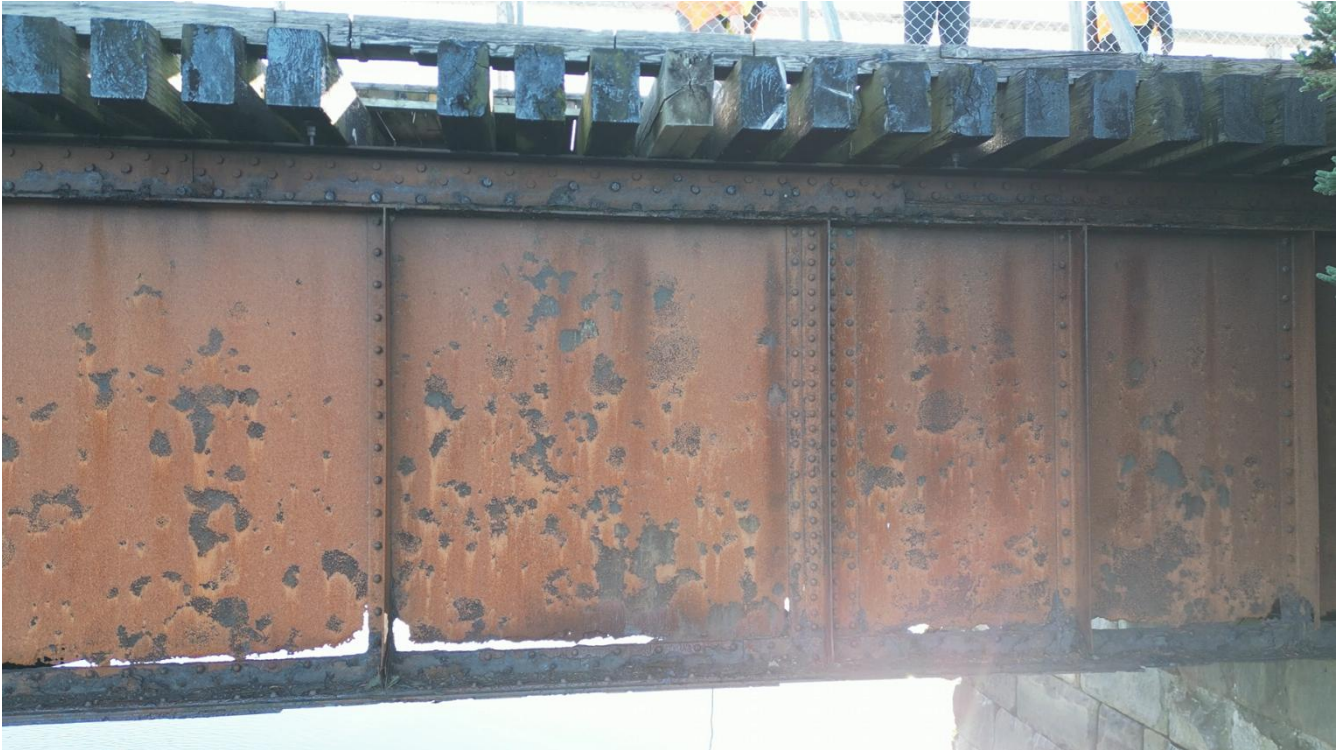
The upper portions of the girders have light to moderate corrosion with no apparent section loss in these areas. In contrast, the bottom portions of the girders exhibit severe corrosion, resulting in significant section loss. This deterioration extends to the webs, bottom flanges, and stiffeners. Most of the section loss has occurred on the webs. See **Figure 3**, **Figure 4**, and **Figure 5** below for a comparison between the 2023 and 2025 inspections.

Photo 23: The most extensive corrosion on the north girder near the west abutment, resulting in severe section loss on the girder web.

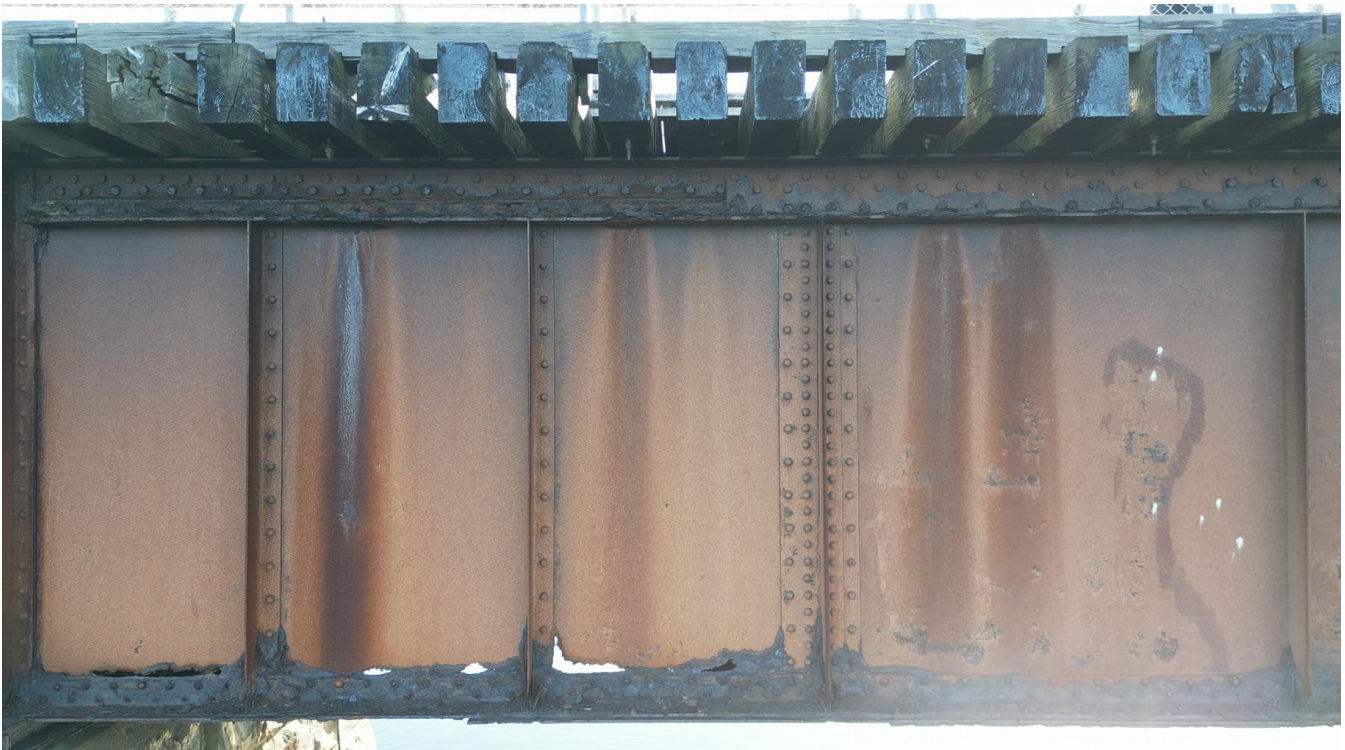
Photo 24: Severe corrosion on the north girder near the east abutment, resulting in section loss.
