# Sandy Point Lighthouse

## Structural Condition Assessment

1586 Sandy Point Road, Shelburne, NS

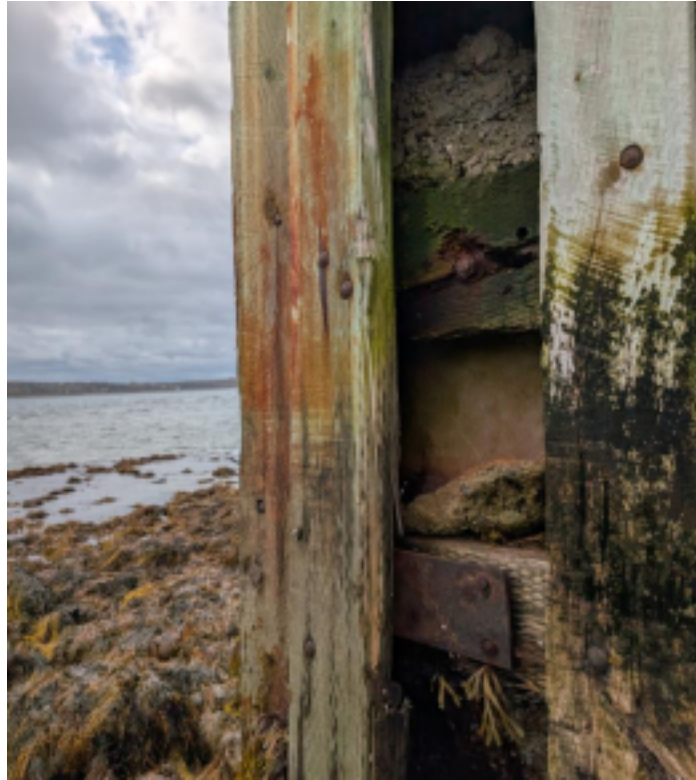
- Several vertical boards were loose, partially detached, or missing as shown in Figure 2. Soft and decaying boards were observed throughout but particularly within the tidal zone, with early signs of decay also noted on many of the boards near the top of the wall.

- Near the high tide elevation, many boards were soft and had lost up to 1" of their thickness. This can likely be attributed to repeated wave impact, as it was primarily noted along the western wall. • The fenders were fastened to the horizontal timbers behind with steel bolts which were severely corroded and many bolts were loose or the hole in the wood enlarged enough that they provide little restraint of the vertical fender.

- Horizontal gaps up to 2" thick were present between the top of the timber fenders and concrete wall at level 1, indicating possible displacement of the timber fender from its original position. • Bowing of the south wall was observed suggesting movement may have occurred in the wall.

Figure 2: View of the deteriorating and lost timber fenders with the concrete wall behind.

We recommend full remediation of the pier foundation is undertaken to stabilize the base from further deterioration. In concept, remediation includes a complete replacement of the seaside timber fenders and to repair the concrete on the interior and exterior while the fenders are being replaced. Due to possible undermining, the base of the concrete foundation should be determined through exploratory digging, which can assess if the foundation depth is suitable for long-term stability or if additional rip-rap stone work is needed at the base. The steel rails on the interior of the pier should be replaced or supplemented with additional corrosion-resistance bracing.

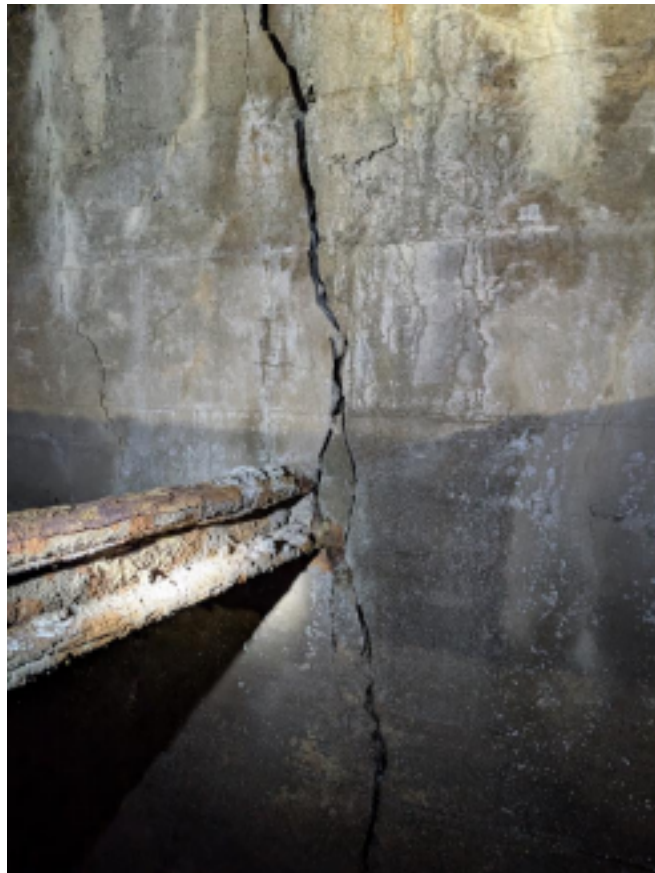
- Several  $\frac{1}{2}$ " to  $\frac{3}{4}$ " wide vertical cracks were noted throughout the concrete foundation walls as shown in Figure 3. There were typically two distinct types of cracks: cracks from the top of the foundation walls extending downward, and cracks spanning vertically between connections of the horizontal steel rails.

- A significant crack is located on the northeast corner, approximately  $\frac{3}{4}$ " wide at the top and 6" deep into the wall, which may suggest possible foundation movement of the north wall.

- Very severe corrosion and delamination were present on the steel rails. Layers of steel flake off easily.
- Significant efflorescence was observed on the steel rails near the rail-to-wall connections. Stalactite-like calcification deposits were observed.

Figure 3: View of typical corrosion of steel bracing and large cracks in foundation wall.

We recommend loose or deteriorating concrete should be chipped and removed to find sound concrete and

replaced with saltwater-resistant concrete. It is unclear if the concrete has reinforcing bars within; if any corroded reinforcing is found, it should be replaced and repaired. Sandy Point Recreation Group could consider adding additional reinforcing to cross existing joints to minimize further crack expansion, although careful detailing and sufficient concrete cover is required to provide longevity to the new rebar.

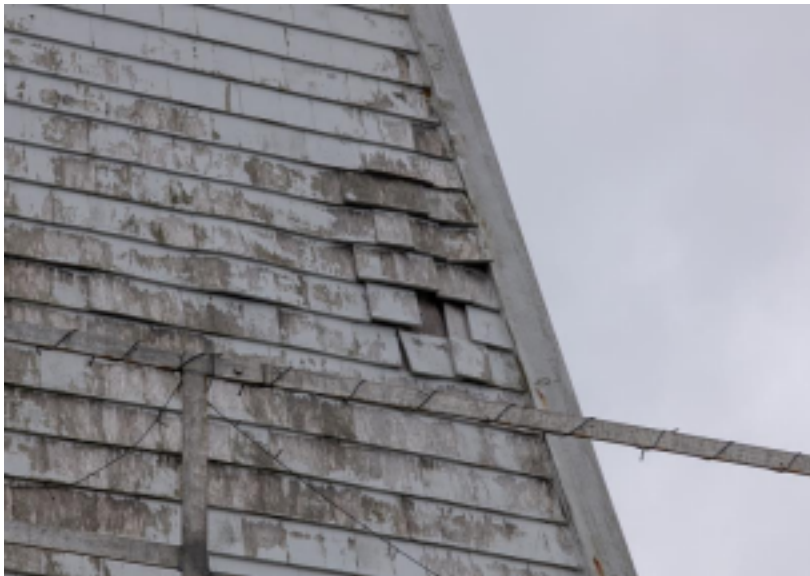
Figure 4: Damaged and missing wood shingles.
