STAFF REPORT

To: Council
From: Adam Dedrick, Director of Recreation & Parks
Approved by: Warren MacLeod, Chief Administrative Officer
Date: December 10, 2025
Subject: Jordan River Trail Bridge Visual Inspection Report

RE: *Jordan River Trail Bridge – Visual Inspection Memo*

Report No: 254216.00

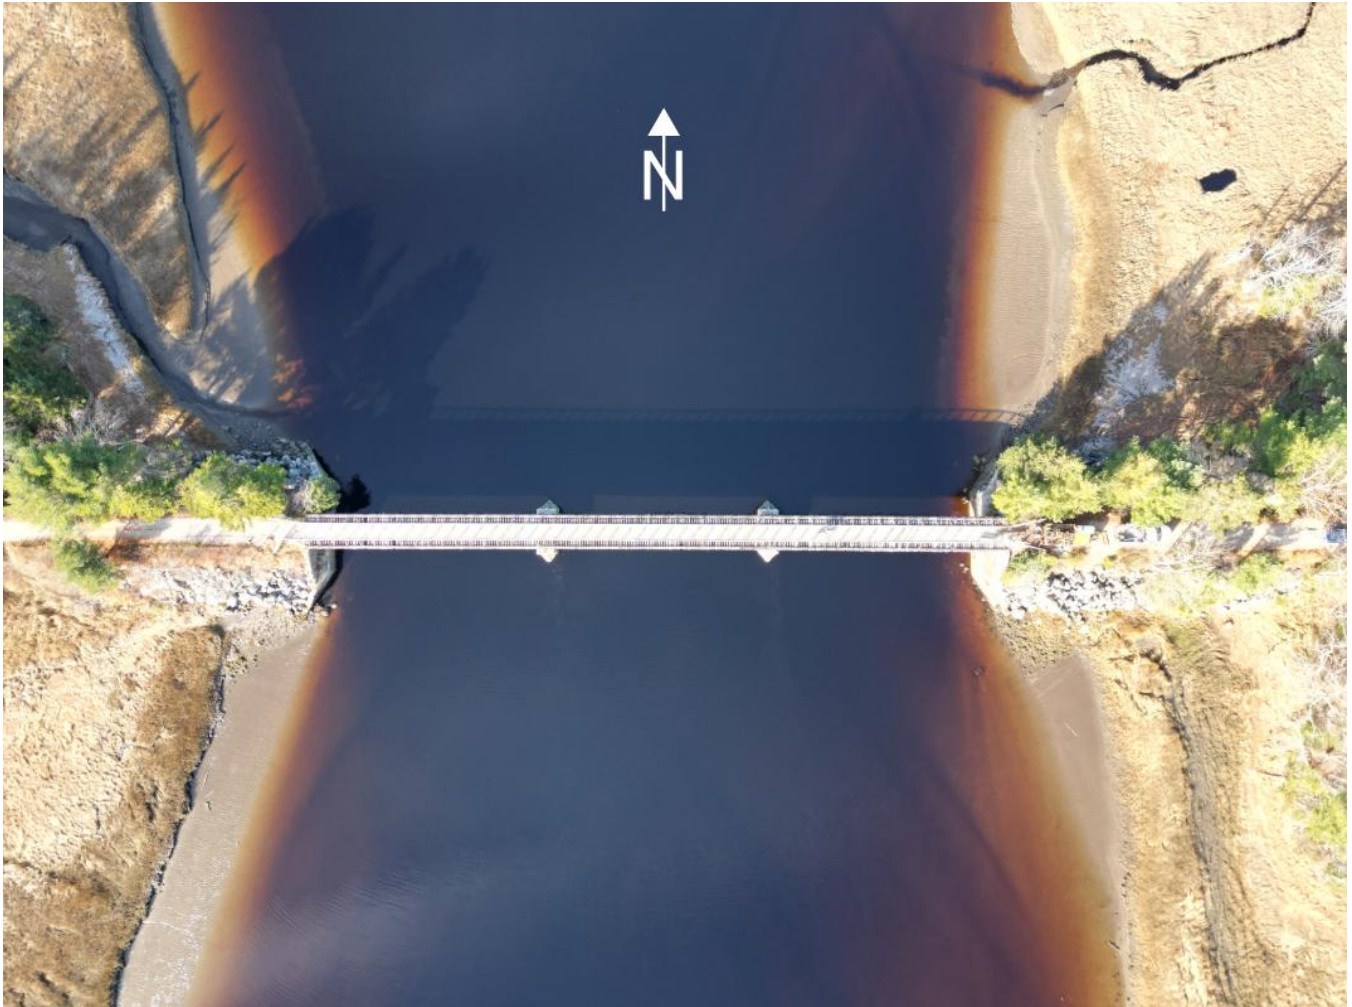
Figure 1 - Site Plan View

CBCL was retained by The Municipality of the District of Shelburne to perform a visual inspection of the Jordan River Trail Bridge, located in Jordan Falls, NS. The inspection was performed on-foot and with the aid of a microdrone. **Figure 1** presents a plan view aerial image of the inspection site.

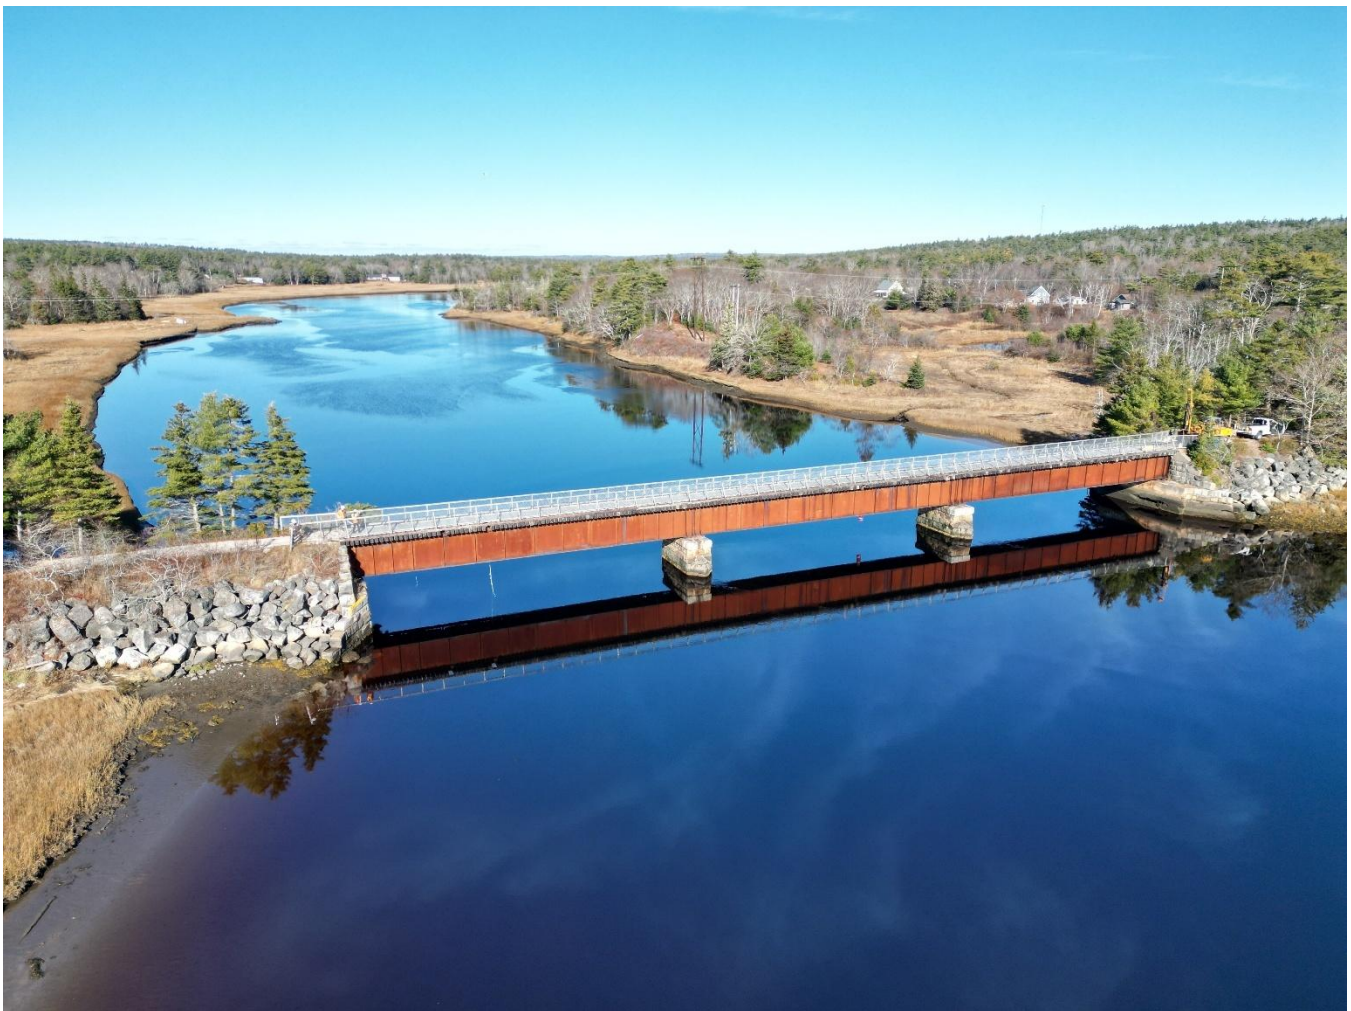
The Jordan River Trail Bridge is a three-span steel girder bridge resting on masonry/concrete abutments and piers, originally constructed in 1906. Originally built for train traffic, the bridge has been converted to service pedestrians, cyclists, and off-highway vehicles (likely in the 1990s). The timber ties lie across the two original girders and support a timber deck and barrier. The clear width of the deck is 1.6 m. From the previous inspection report, the east, center, and west spans were measured at approximately 25.6, 25.7, and 25.8 m, respectively, for a total length of 76.2 m.

Figure 2 - Aerial view of Jordan River Trail Bridge. Picture facing north.

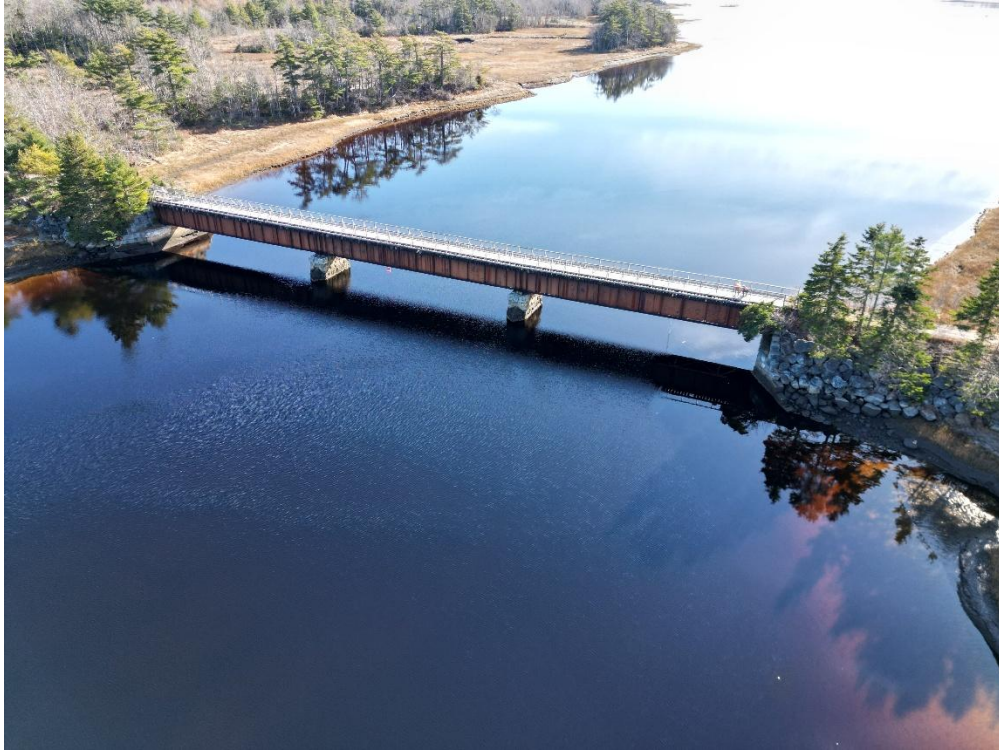
Photo 1: Aerial overview of Jordan River Trail Bridge, facing south.

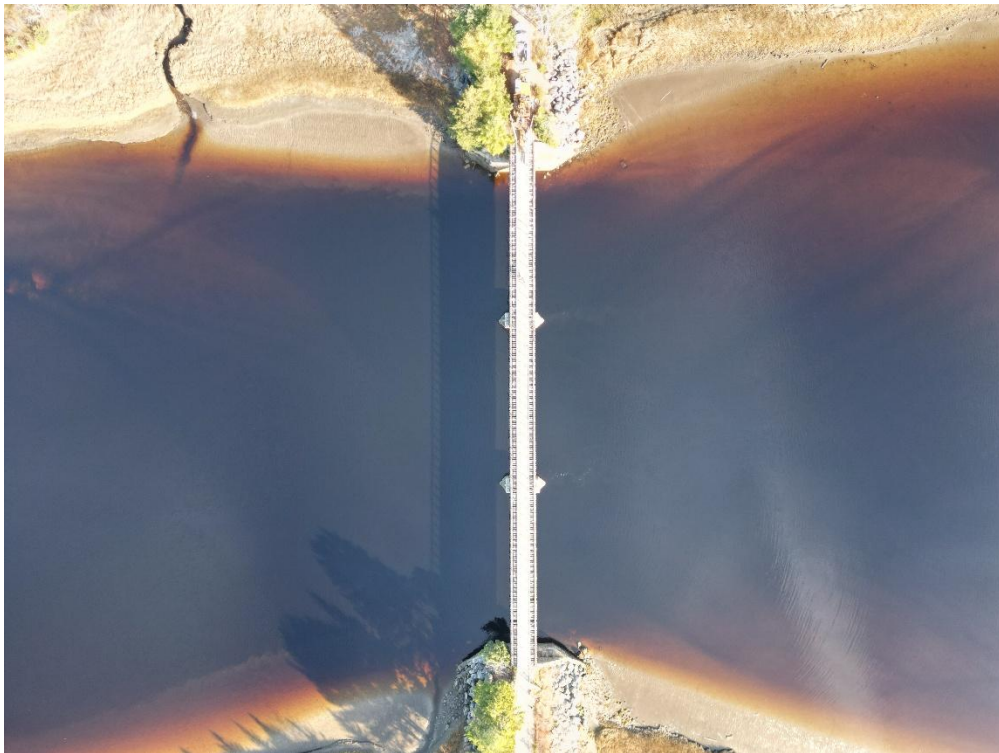
Photo 2: Aerial plan view of the Jordan River Trail Bridge.
